Manhole Inspection Summary

Manhole # S11CC2002MH

Insp Date: **7/18/06 8:46 AM**

Location Address: **2406 ROCKWOOD AVE**

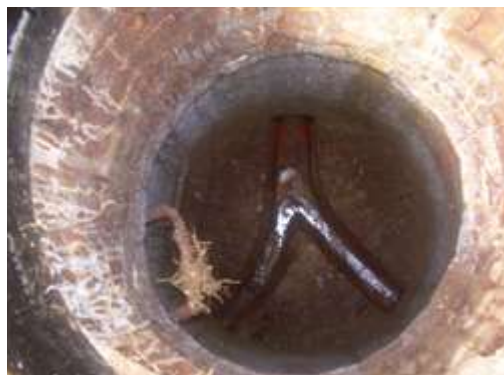
Top View

Corroded steps. Evidence of surcharge - Bench debris. Channel debris.

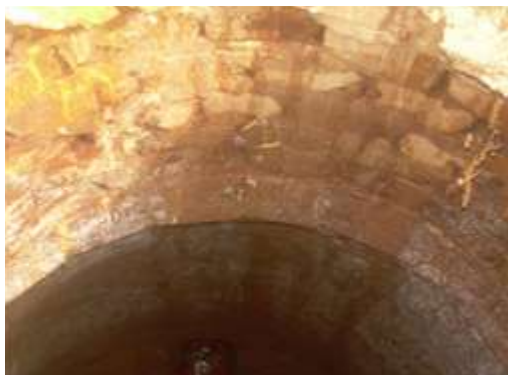
Defect

Adjustment deterioration and infiltration. Barrel infiltration - other side.

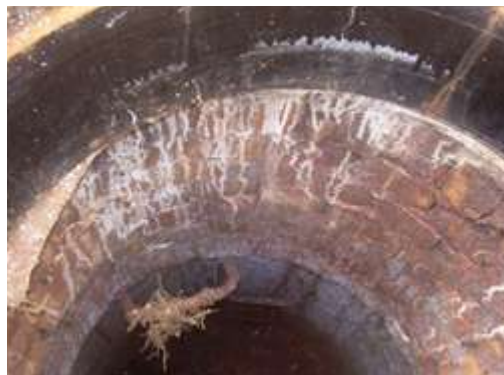
Defect

Adjustment deterioration and infiltration. Barrel infiltration.

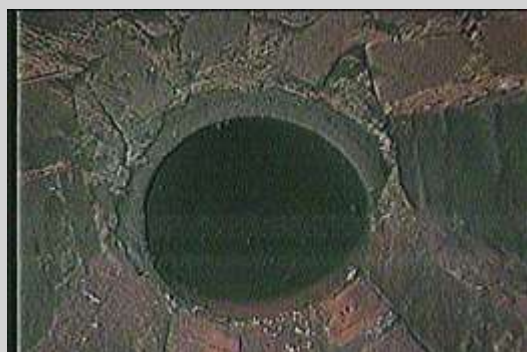
Pipe Out @ 12 O'Clock

Infiltration: **Evidence** Pipe Seal Cond: **Cracked**

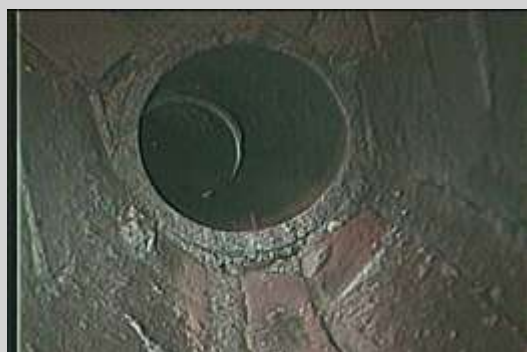
Pipe In @ 4 O'Clock

Channel deterioration.

Infiltration: **Evidence** Pipe Seal Cond: **Broken**

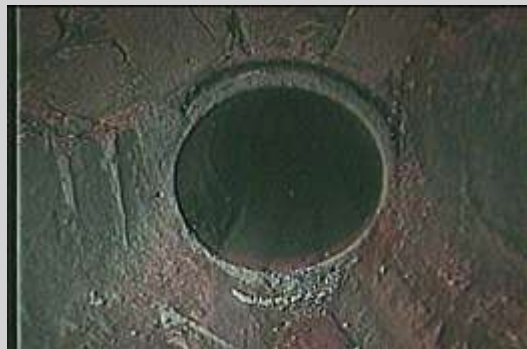
Pipe In @ 7 O'Clock

Infiltration: **Evidence**

Pipe Seal Cond: **Cracked**
